## Enhance the voltage drop in the end costumer of PT. PLN ULP 50 Kota using insertion transformer

Syafwanil Arif<sup>1</sup>, Habibullah<sup>1</sup>

<sup>1</sup>Department of Electrical Engineering, Faculty of Engineering, Universitas Negeri Padang, Padang, Indonesia

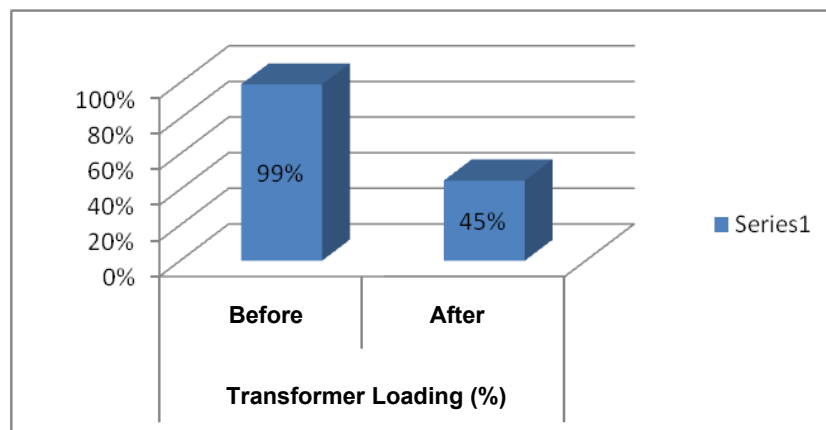
Figure 1. Comparison of loading percentage before and after installing the insert transformer

Based on the graph above, it can be seen that the percentage of loading of the GD 175 Kasiak transformer previously completed showed a value of 99%, which is where this figure exceeds the distribution transformer loading capacity, or it can be said that the transformer is in Overload status. After the construction of the insert transformer, the results showed that the transformer loading had been divided with the insert transformer and showed a figure of 45%. When compared to the applicable SPLN standards, the transformer loading percentage status can be said to be normal. This shows that the handling of excessive loading on the transformer which was overcome by building the insert transformer was successful. Transformer loading that is in accordance with this standard improves customer service.

Based on the calculation results, it can be seen that the percentage of transformer loading after the transformer insertion is 45%; this figure is in accordance with applicable standards. The results of the end voltage measurement after the construction of the insert transformer are 227 volts; this figure is in accordance with applicable standards. Based on the results of calculations and measurements carried out by the author on the data of the GD 175 Kasiak Rampu Transformer, the percentage of loading and end voltage before and after the construction of the insert transformer can be seen in Figure 1.

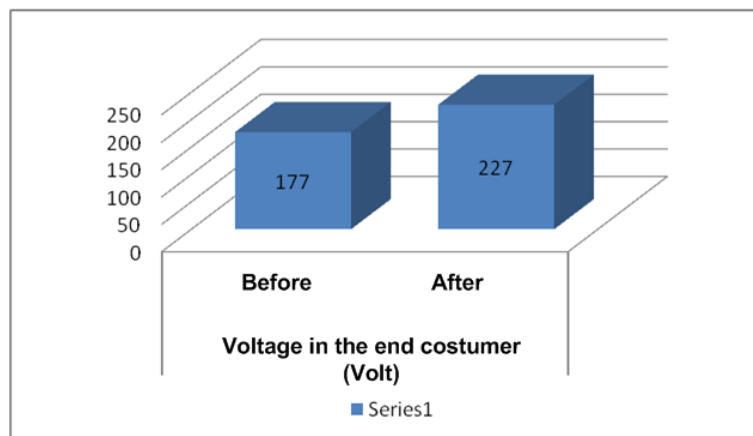
The installation of the insert transformer has been able to increase the voltage level at the consumer end from 177 Volts to 227 Volts, as shown in the graph in Figure 2. Based on the graph in Figure 2, it can be seen that with the construction of the insert transformer on the GD 175 Kasiak Rampung transformer, it causes a change in the customer end voltage, namely at the beginning the voltage was measured at 177 Volts, after the insertion it became 227 Volts. Where this value is in accordance with the applicable SPLN standards.

Figure 1. Comparison of the voltage at the end customer before and after installing the insert transformer
